Stream Condition Assessments and Reporting

FIRE SITES

June 2009

Project Name	Stream Condition Assessments and Reporting – Fire Sites
Client	Goulburn Broken CMA
Client project manager	Mark Turner
Water Technology project manager	Jamie Kaye
Report authors	Sally Day
Job number	J1085
Report number	R01
Document Name	R01v02_J1085_Fire_Sites

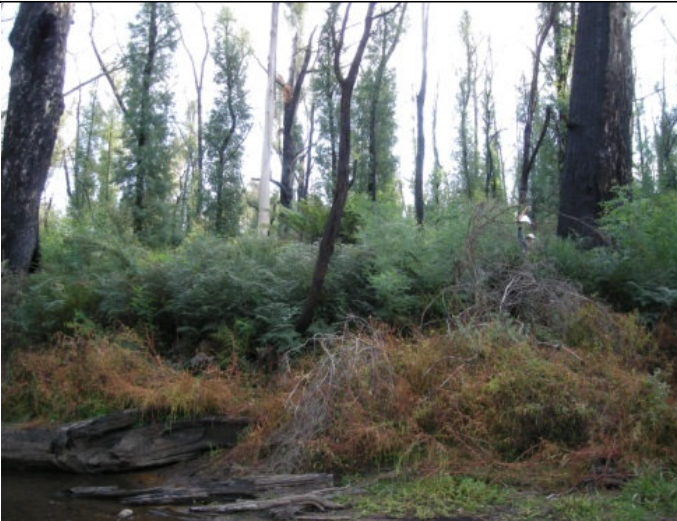
Severity Class	Water Technology Interpretation Comments	Representative Photo
<p>1</p>	<p>Crown burn</p> <ul style="list-style-type: none"> - Many trees dead, extensive epicormic growth on Eucalypts - Total destruction of mature woody understorey <p><i>Site 15 – Howqua River</i></p>

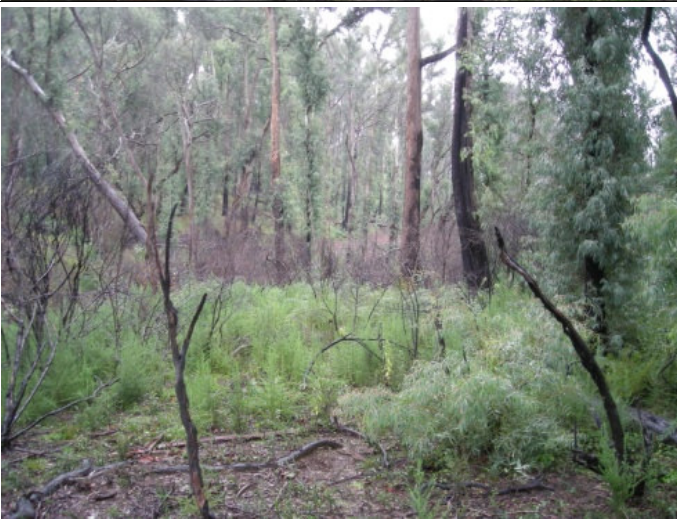
<p>2</p>	<p>Crown scorch</p> <ul style="list-style-type: none"> - Occasional tree dead, extensive epicormic growth - Total destruction of mature woody understorey <p><i>Site 5 – Holland Creek</i></p>

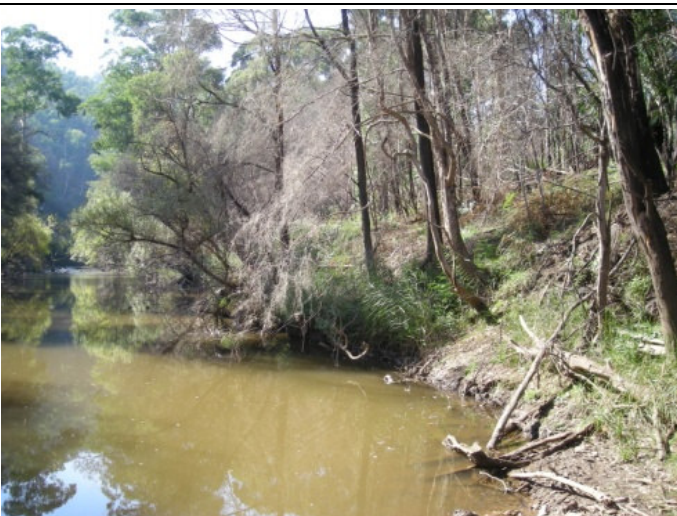
<p>3</p>	<p>Moderate crown scorch</p> <ul style="list-style-type: none"> - No dead trees, much epicormic growth - Most woody understorey burnt, channel fringing vegetation often unburnt <p><i>Site 13 – Goulburn River</i></p>

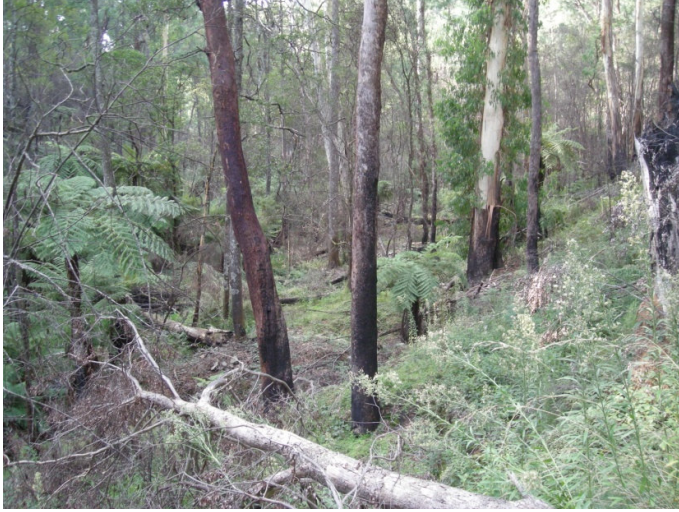
Severity Class	Water Technology Interpretation Comments	Representative Photo
4	<p>Light crown scorch</p> <ul style="list-style-type: none"> - Patchy burn <u>or</u> - Some crown scorch and associated epicormic growth - Moderate understorey damage <p><i>Site 3 – Bakers Creek</i></p>

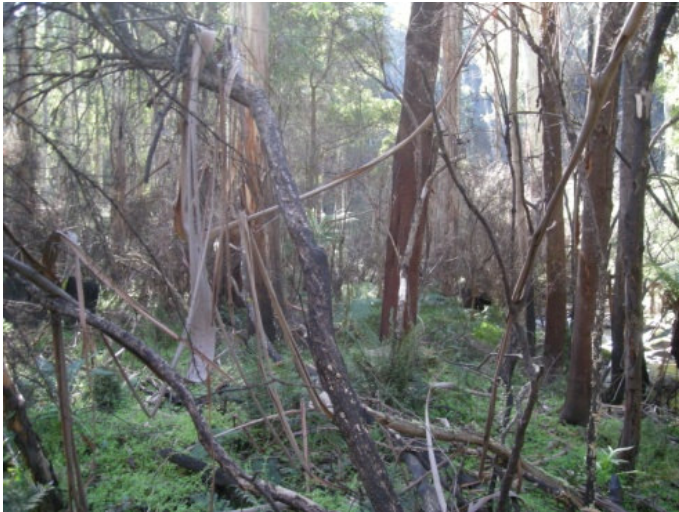
5	<p>No crown scorch</p> <ul style="list-style-type: none"> - Canopy intact - Cool understorey burn with most woody understorey surviving <p><i>Site 18 – Delatite River</i></p>
