Nagambie Tunnel Erosion Project

Brad Costin

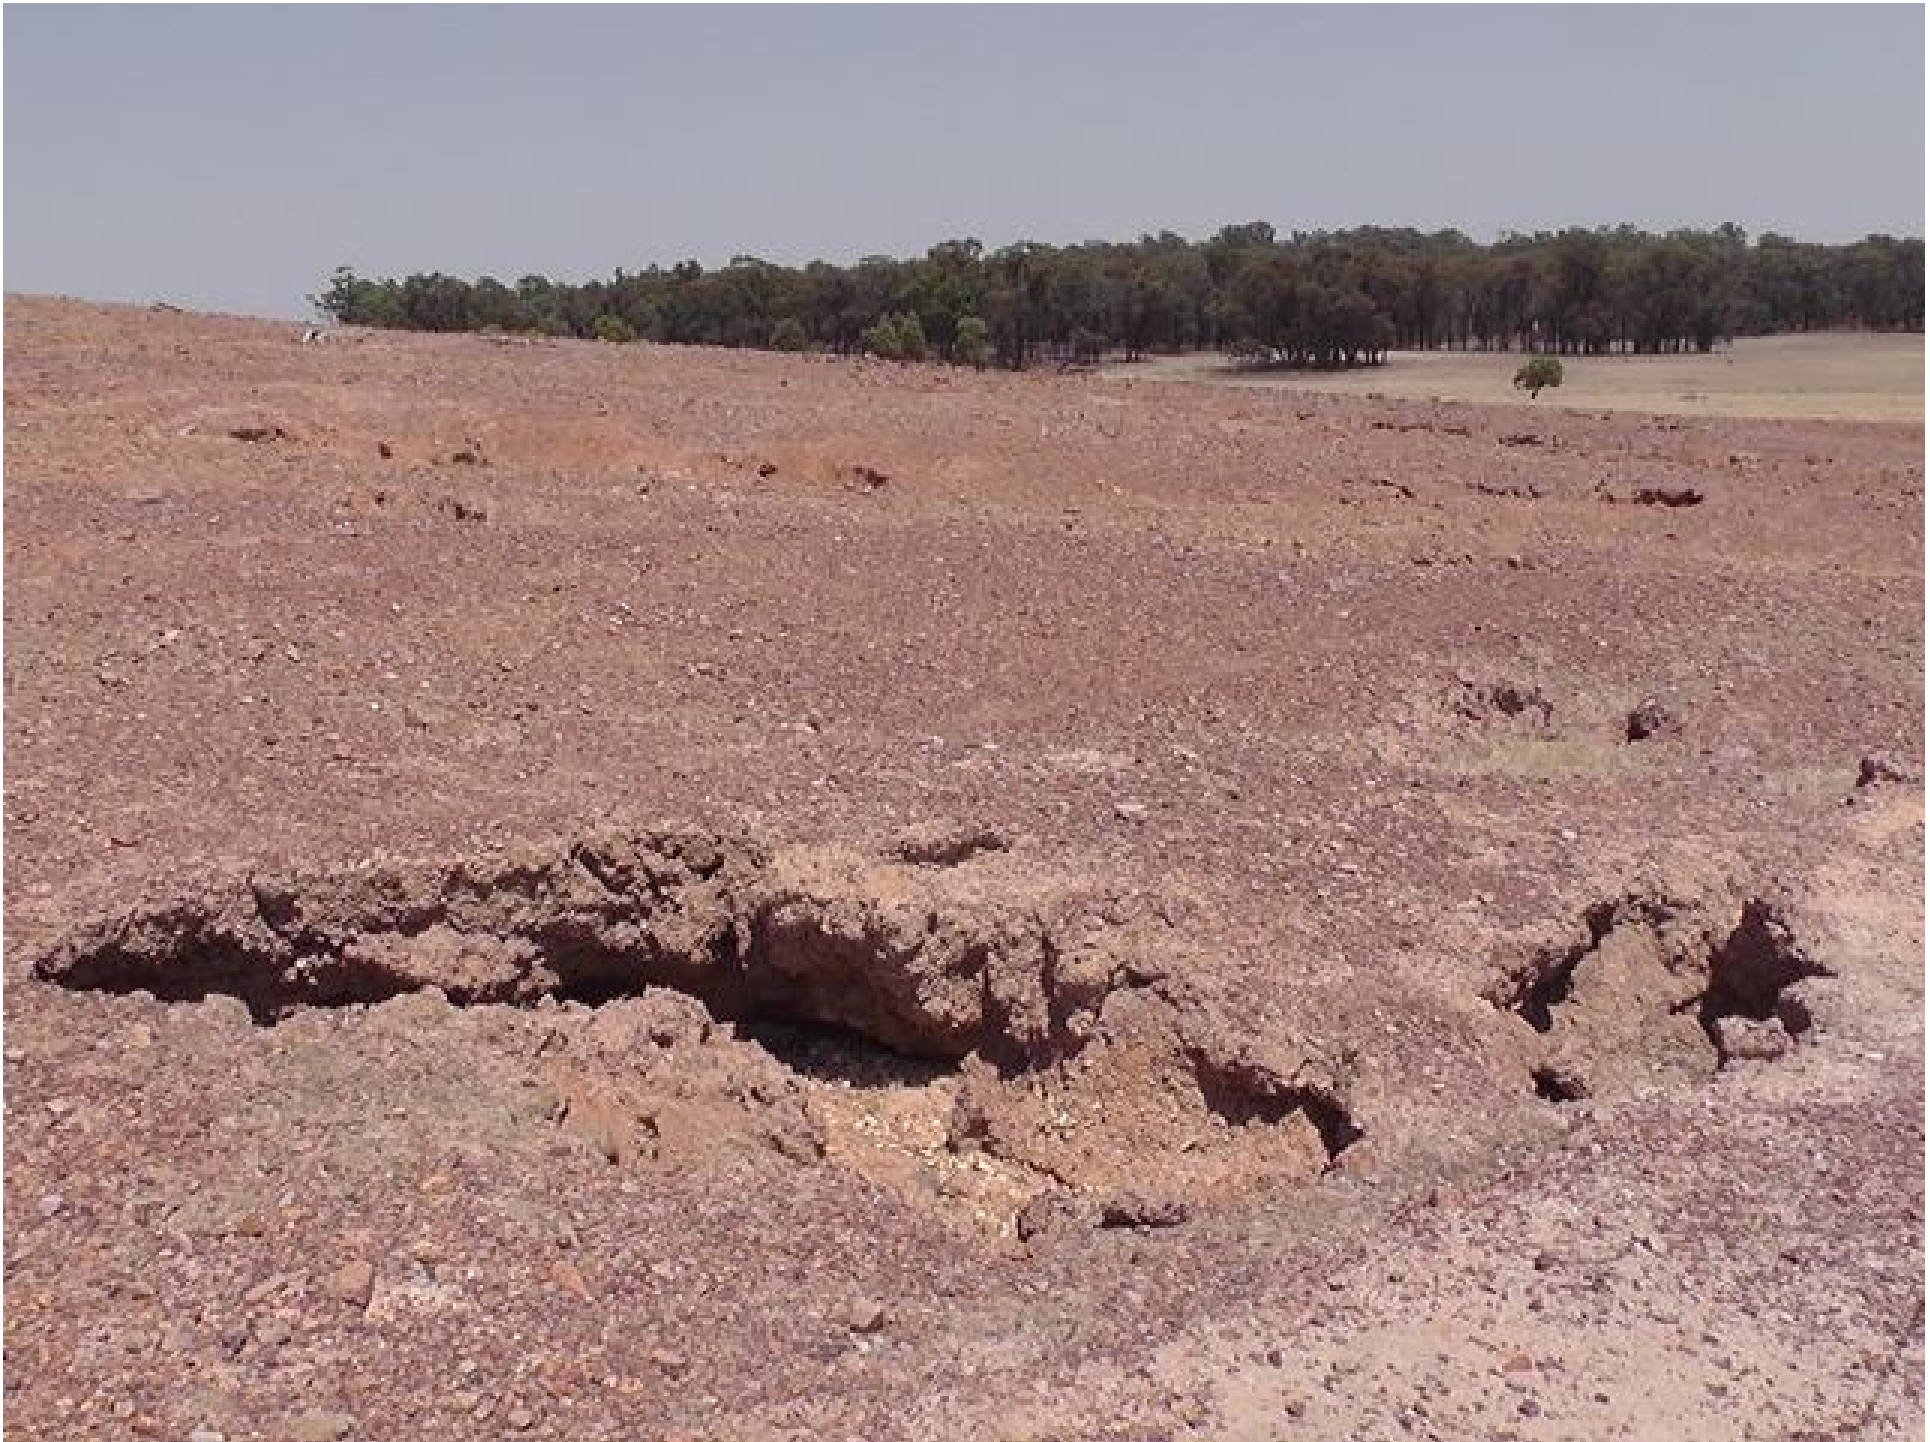
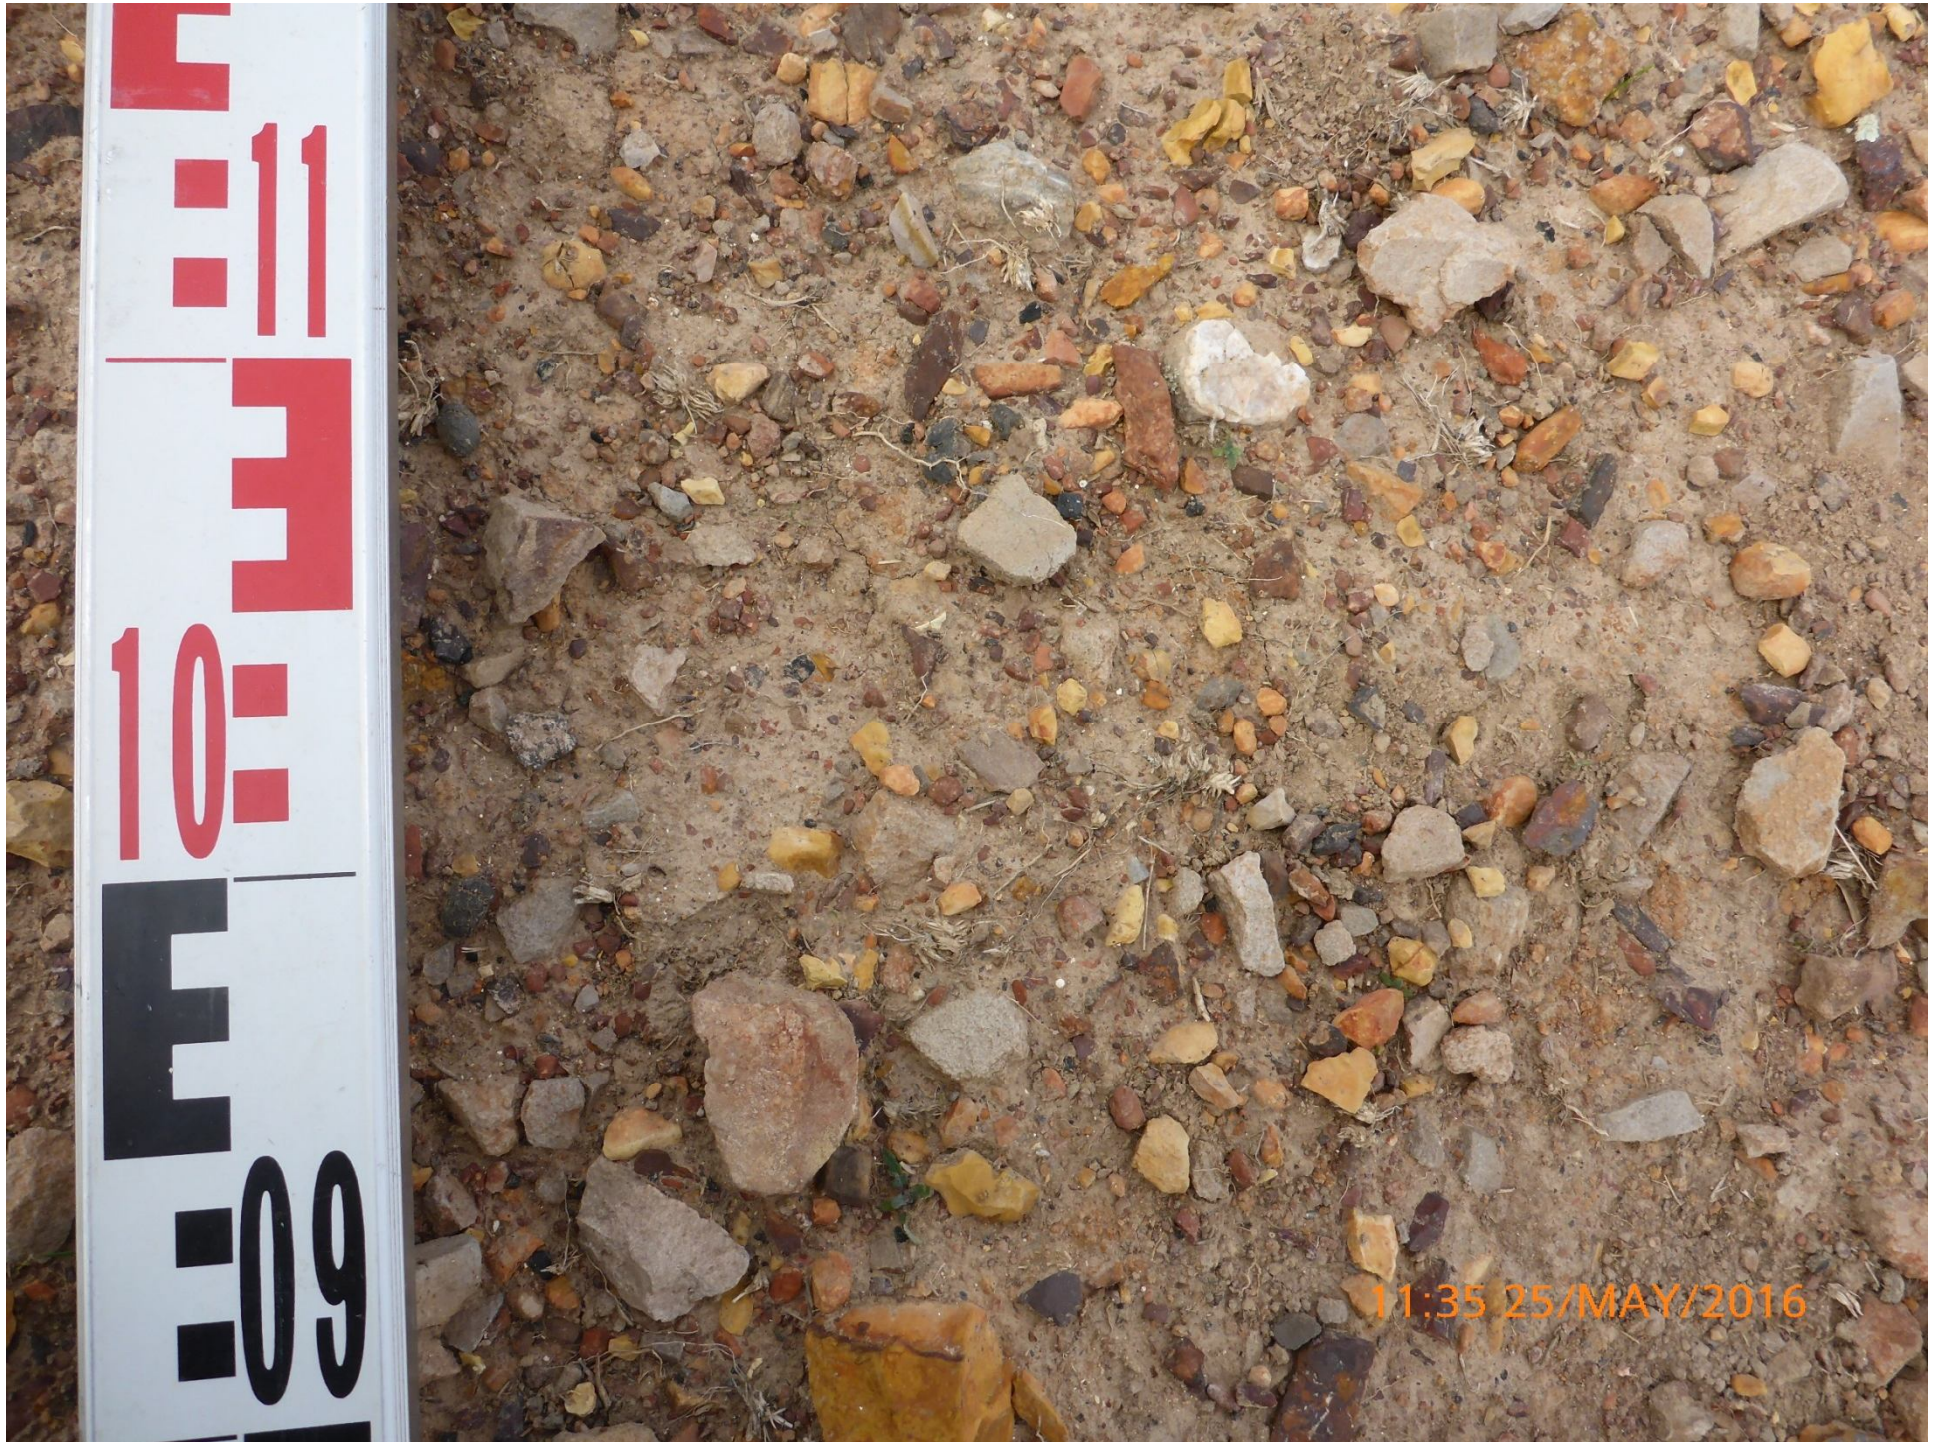
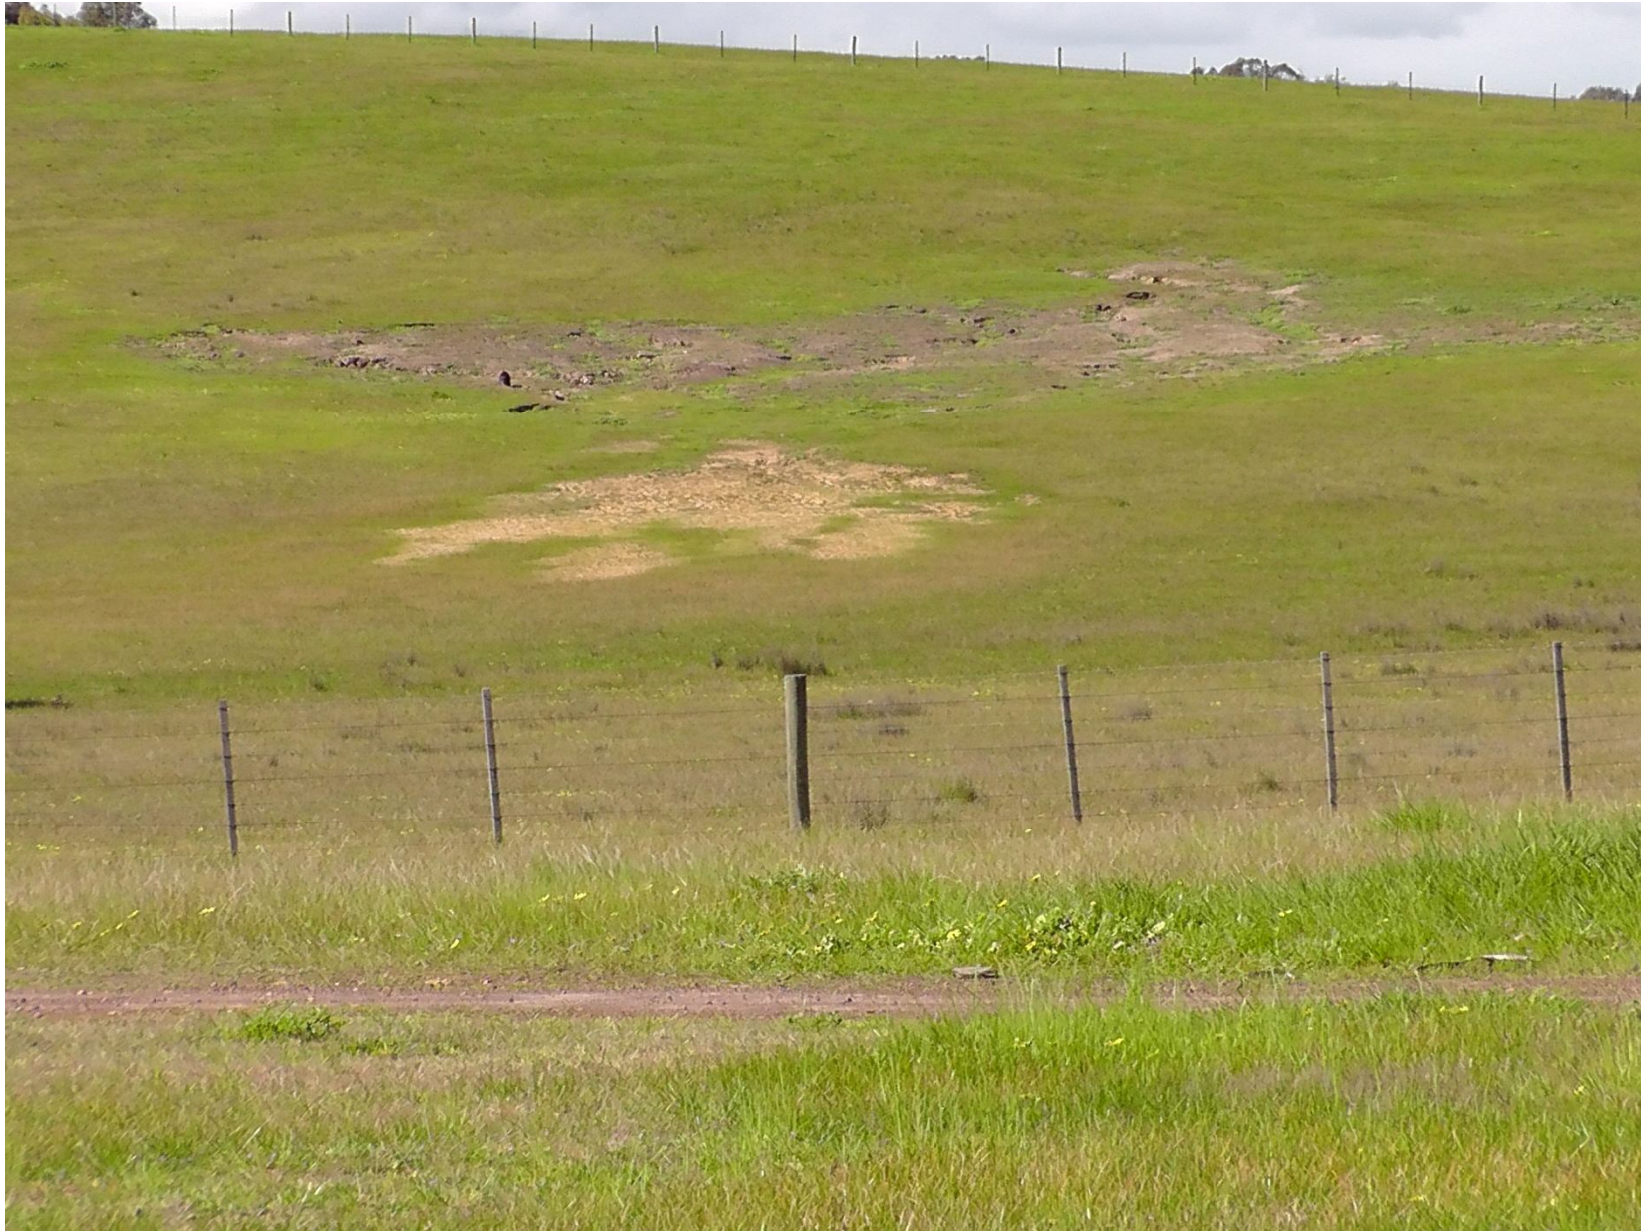
Site details

- 4 hectares erosion within a 40 ha paddock
- Tunnel erosion, sheet erosion, small gullies and rills

- Ground cover 0-1%
- Sedimentary soils

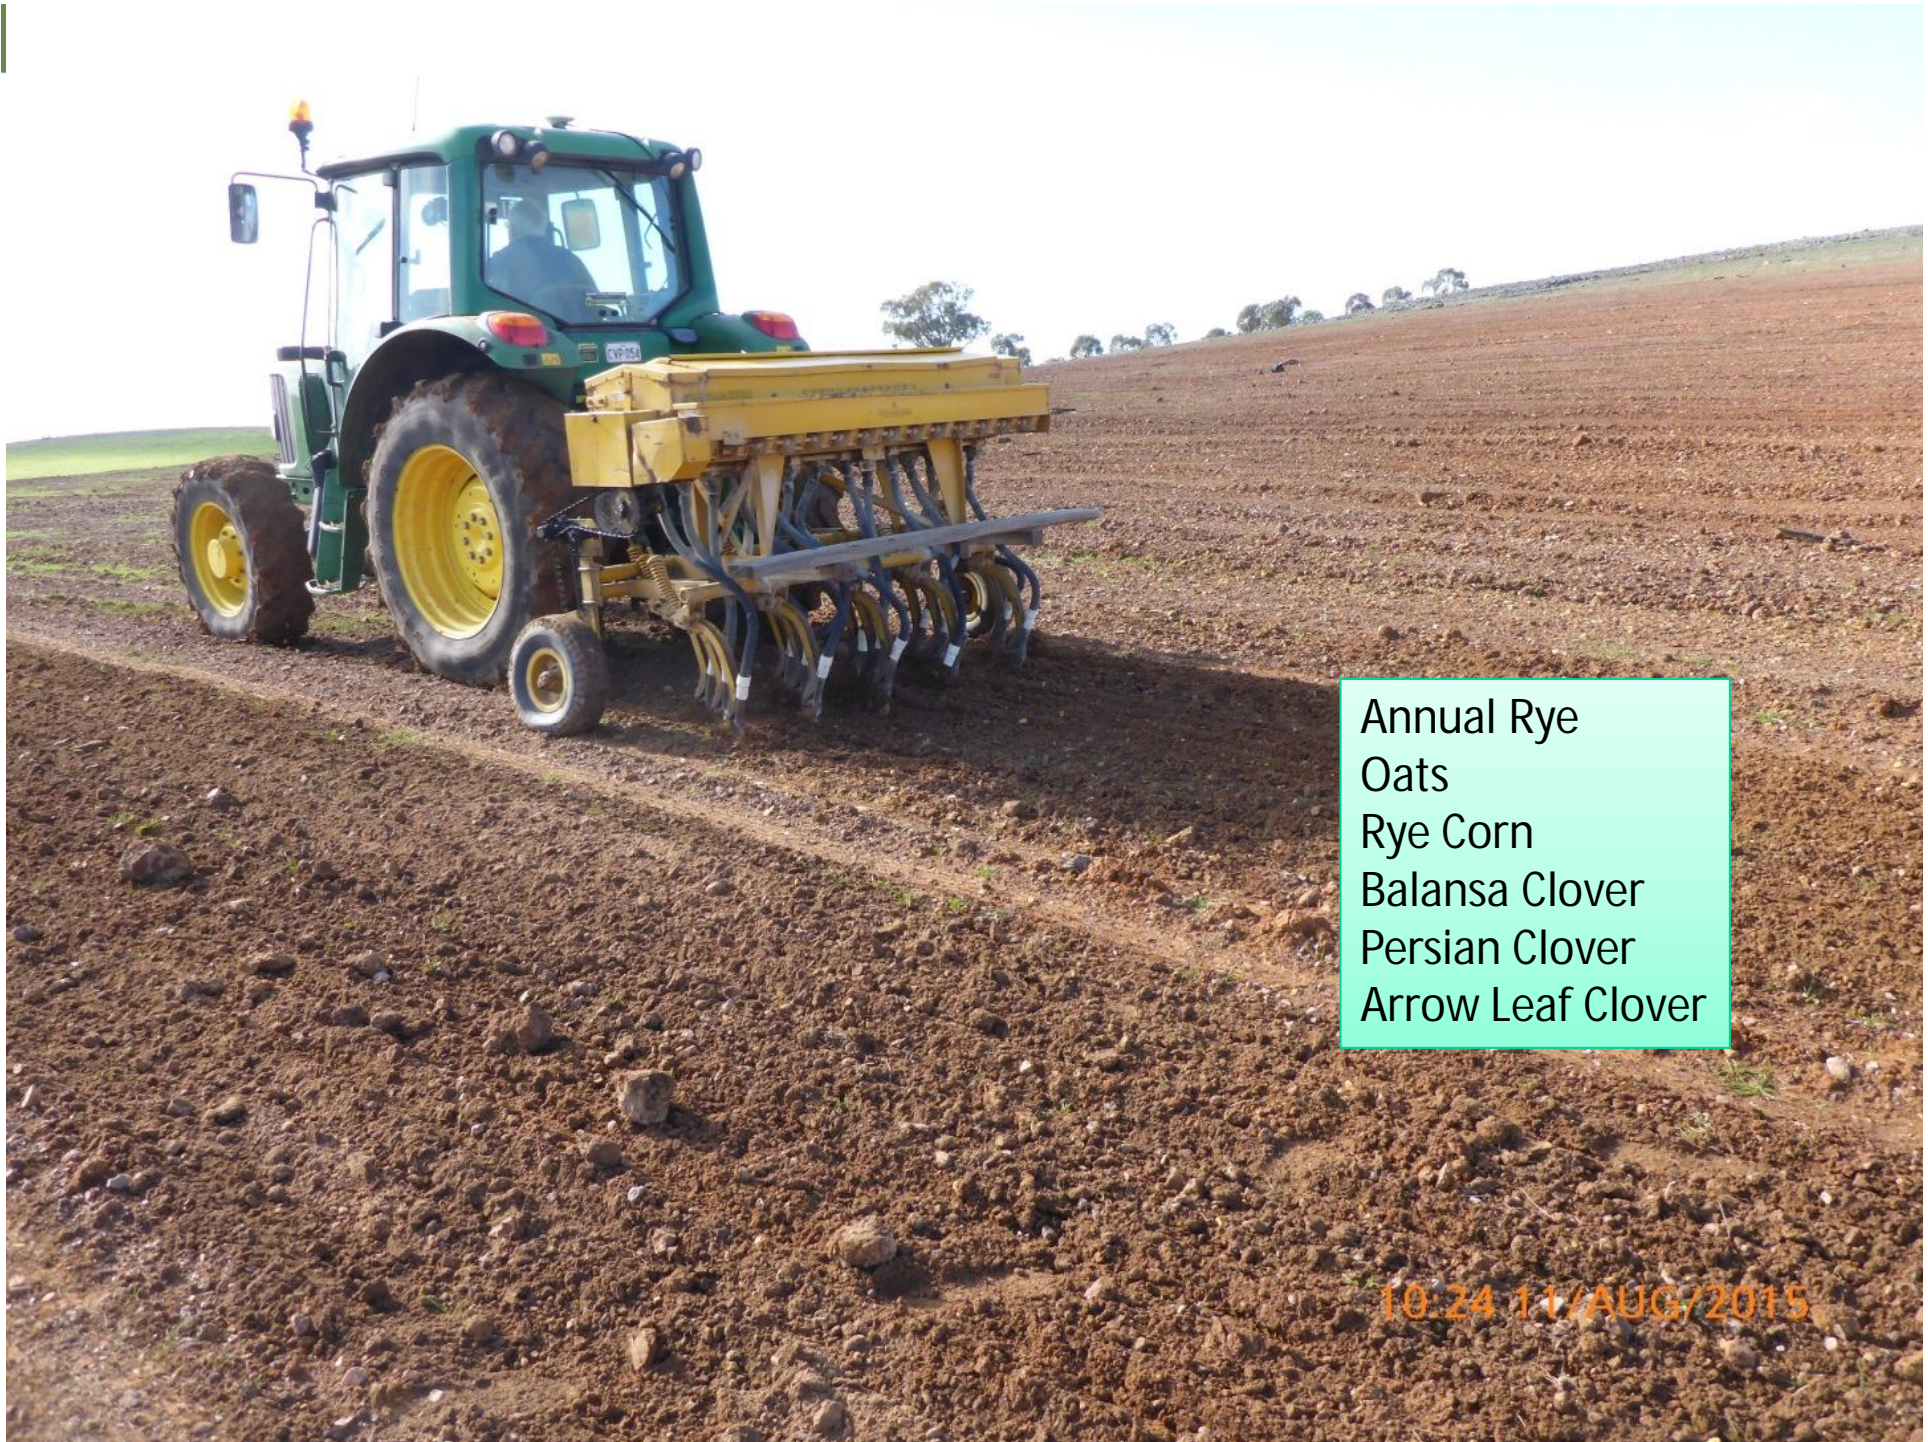
10.24 11/AUG/2015

Annual Rye
Oats
Rye Corn
Balansa Clover
Persian Clover
Arrow Leaf Clover

- Dry seasonal conditions August 2015
- Low pasture establishment
- Stalled spreading treatments

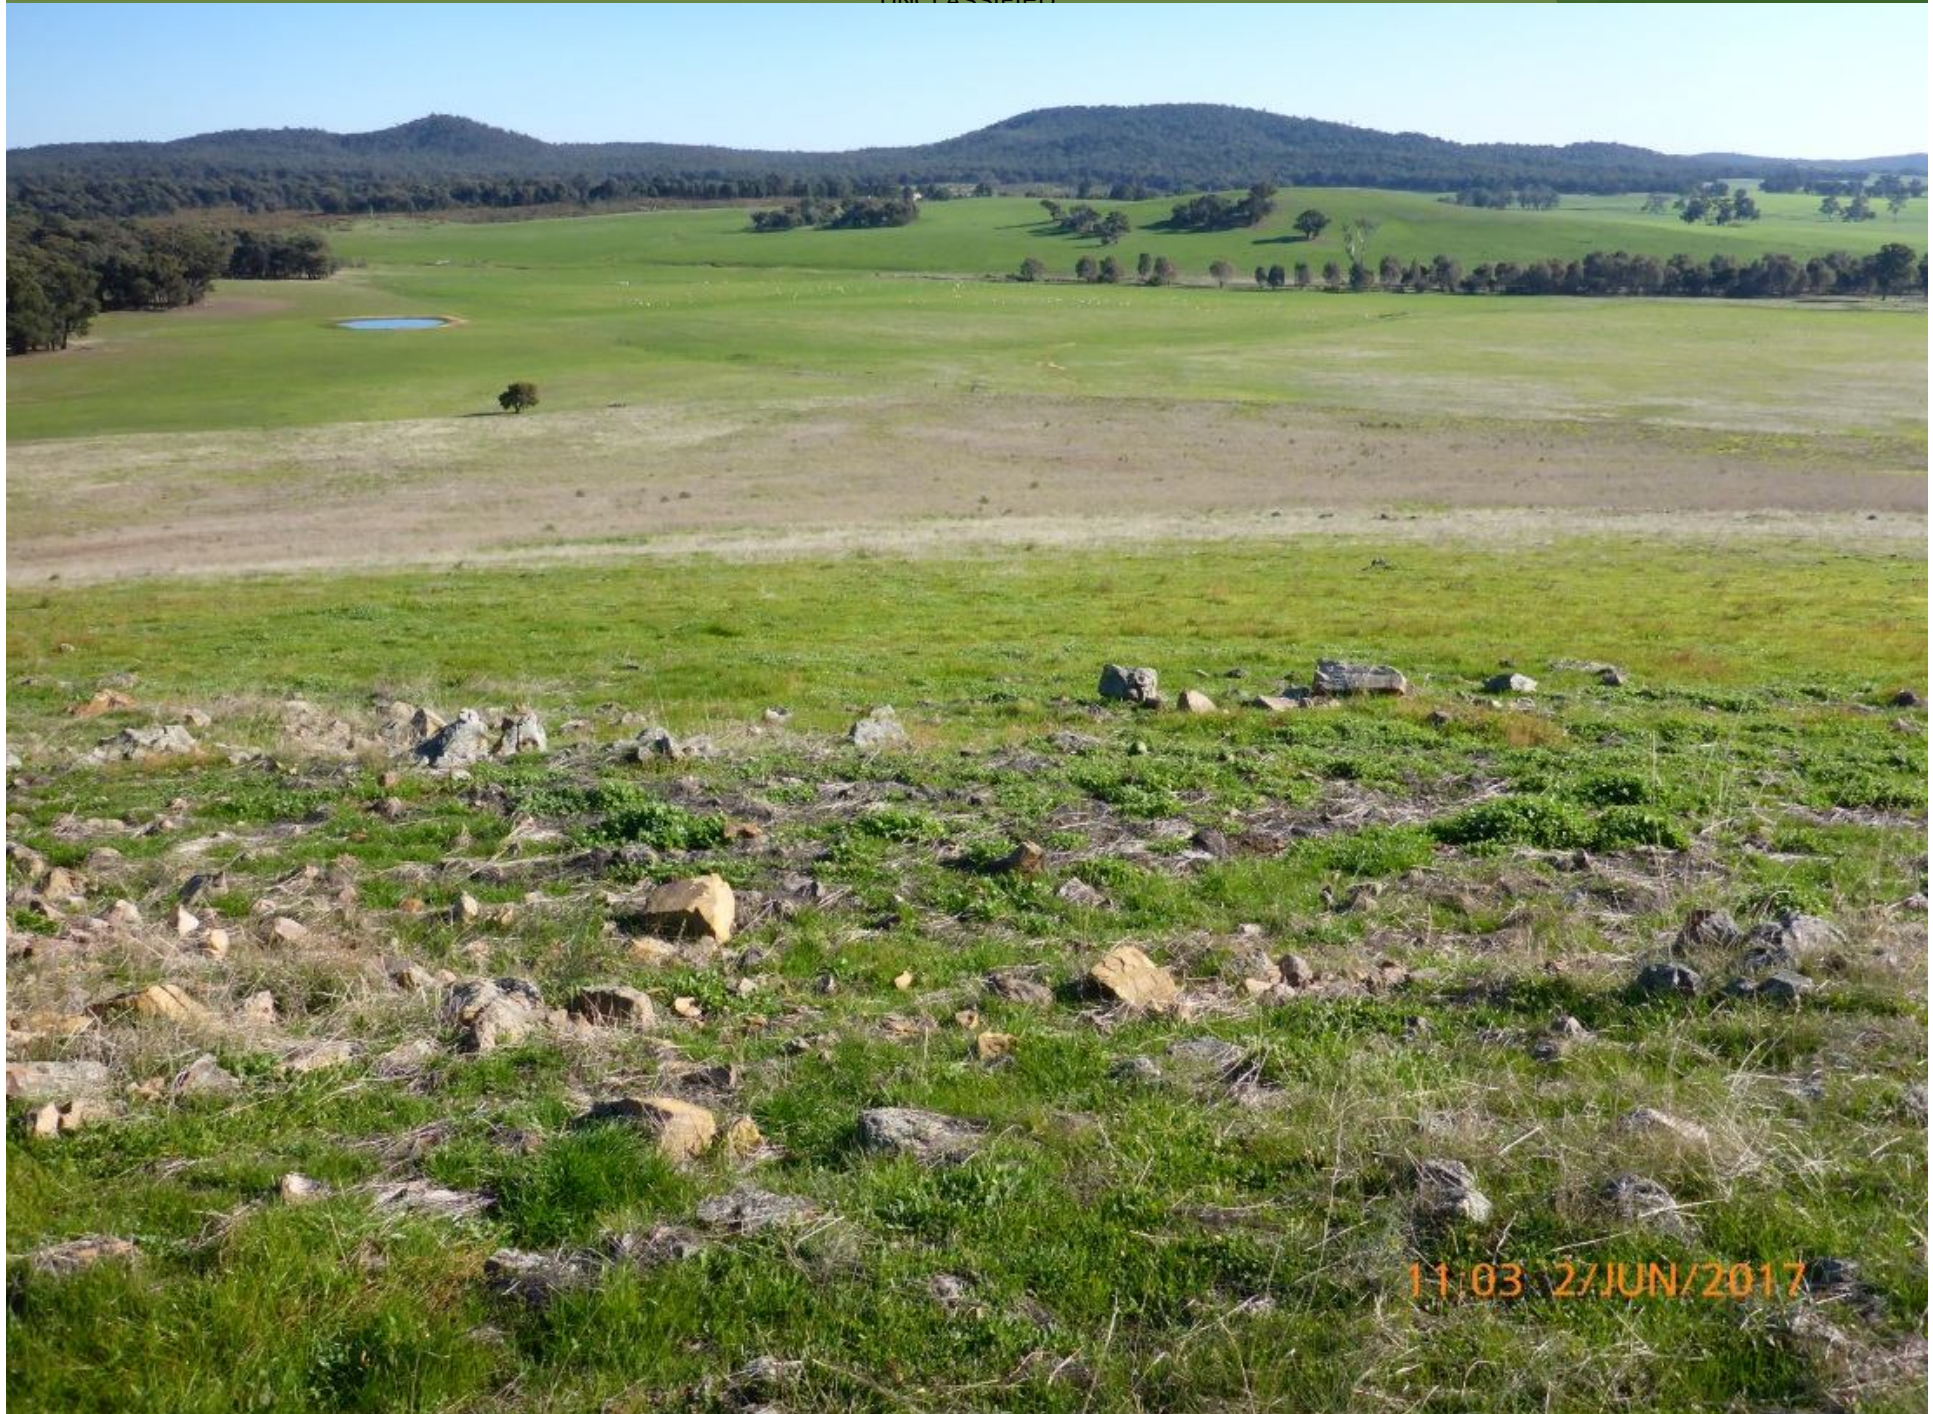
11:03 2/JUN/2017

- Second sowing attempt a great success
- Lucky we didn't spread mulch
- Landholder spread super and gypsum again
- Remaining issues:
 - Chicken manure spreading
 - What to do with the mulch
